C-5 A FUSELAGE STRESS ANALYSIS

Report No. TR-92-7

June 1992

Operated for the Flight Dynamics Directorate by CSA Engineering, Inc.

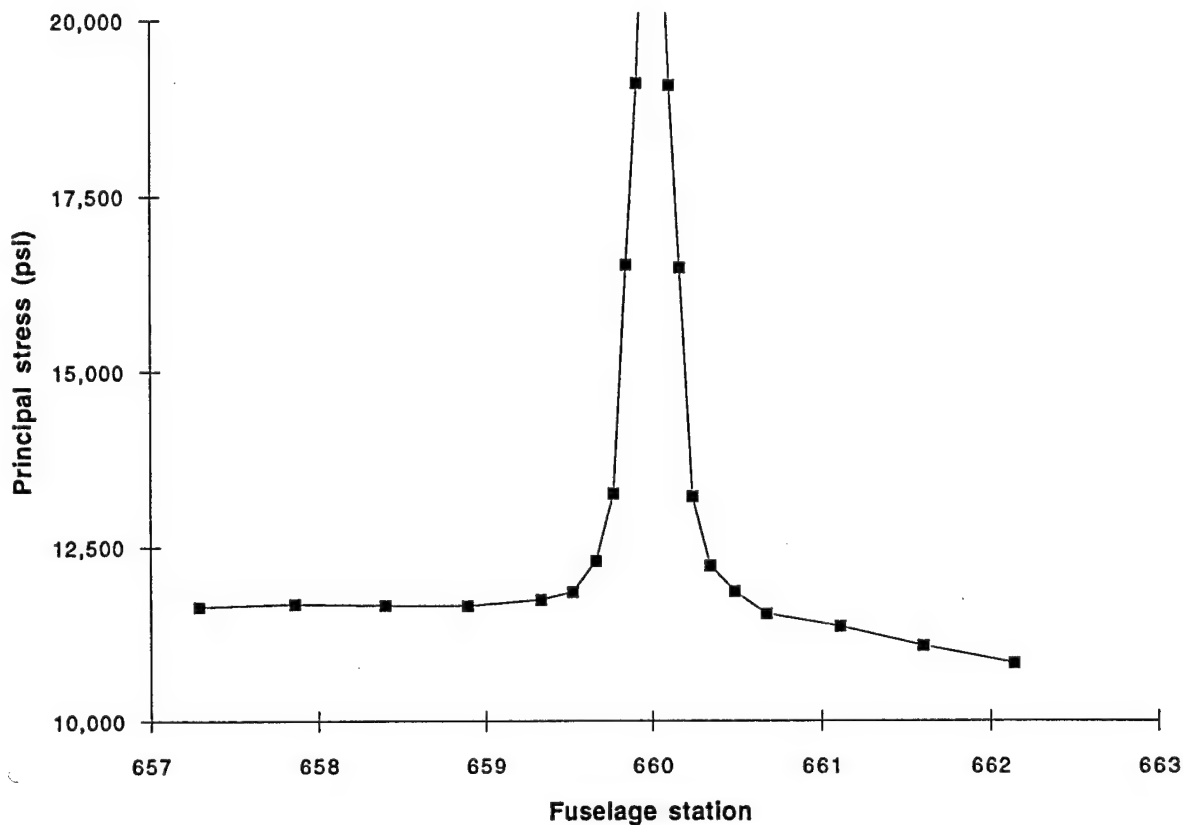
Figure 2: Maximum principal stress along WL 295 near a typical fastener at FS660

Internal pressure: The results from the baseline static stress analysis with only uniform internal pressure were as expected. In particular, the stress level in the fuselage skin panel in the hoop or circumferential direction remote from the fastener hole ranged from 10,000 to 12,000 psi. The theoretical value of the hoop stress in a thin-walled cylinder of 143" radius and 0.068" thickness when subjected to uniform radial pressure of 8.3 psi is 17,454 psi. Evidently, the frames and titanium doublers are picking up significant amount of load. The theoretical value of the meridional stress for an equivalent thin-walled cylinder is 8,727 psi; in the fuselage skin remote from the hole, meridional stresses ranged from 6,500 to 7,500 psi; the rest, apparently, is carried by the stringers. The major principal stress near the fastener hole was 19,100 psi, a jump of 75% from the stress observed in the areas remote to the fastener hole. Figure 2 shows a plot of the maximum principal stress along WL 295 near a typical fastener, which in this case was modeled at FS660.

Internal pressure with cargo load: When the cargo load is present, the major principal stress near the fastener hole increases from 19,100 psi to 19,860 psi and the location of the point where the maximum occurs shifts by 30 degrees from the horizontal. Additionally, as expected, the stresses in the fuselage skin near the cargo floor are high. Overall, the presence of cargo load influences the WL295 stresses only

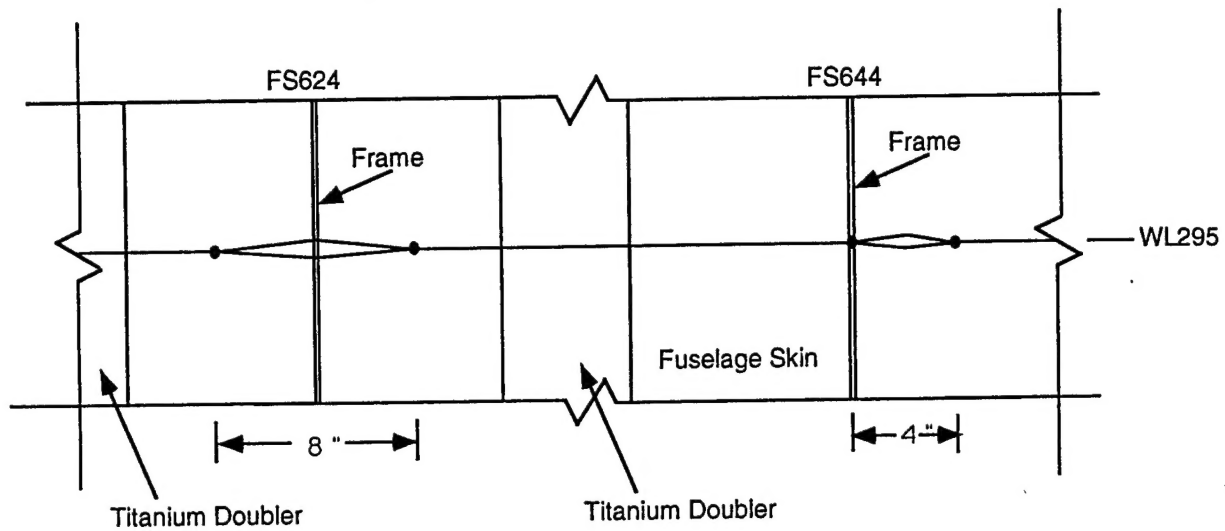
Figure 3: Cracks at WL 295; first crack pattern

Figure 3 shows the crack pattern along WL295 that was used to assess the effects of typical cracks on frames. Specifically, three cracks were modeled: one 8" crack along WL295 centered at FS624 was modeled to determine its effect on the frame at FS624; one 4" crack was modeled from FS644 to FS648 to obtain its effects on the FS644 frame; and one 0.14" crack was modeled at the fastener hole to determine the stresses in the fuselage skin ahead of the crack when a crack initiates and propagates from the fastener hole along WL295.

Internal pressure: For the internal pressure load only, the principal stress ahead of the crack near the fastener hole was 15,770 psi; the stress at the same location for the baseline analysis was 13,210 psi, a jump of 20%. Also, the maximum principal stress at the fore edge of the fastener hole increased from 19,100 psi to 20,430 psi. Table 2 shows the forces in the frames under various conditions. Note that an 8" crack causes the bending moment in the FS624 frame at WL295 to increase from 7,503 in-lb to 15,713 in-lb, or 109%. The axial force increases from 5,350 lb to 8,092 lb, or 51%. The 4" crack near the frame at FS644 increases the bending moment by 57% and the axial force by 11%.

Internal pressure with cargo load: The maximum principal stress at the fore edge of the fastener hole, for this load case, rose from 20,380 psi to 21,530 psi; the principal stress at the aft edge dropped from 19,860 psi to 15,490, however. Table 2 shows the forces in the frames when the cargo load is present. The presence of an 8" crack caused the bending moment in the FS624 frame at WL295 to increase from 4,893 in-lb to 12,417 in-lb, an increase of 154%. The axial force increased from 5,618 lb to 8,200 lb, an increase of 46%. The forces in the FS644 frame did not change significantly, however.

So far, it appears that no simple solution exists for the correction of the skin cracking problem. Although most of the cracks occur along WL 295, it appears prudent to develop a repair that applies to all cracks or to develop a set of repairs covering all cracks. The current repair involves putting titanium doublers on both sides of the cracks. The drawback of this repair is that it requires more holes be made in the skin, thus creating the potential for more crack sites. Other possible repairs include unloading WL 295 fasteners by designing a new structure for supporting the external fairing and routing the loads down to the next lower stringer. Also, the cracks occurring at other stringers could be eliminated by putting doublers on the opposite side of the skin. These repairs will not address the corrosion damage that already exists in these areas. Another repair that addresses all of the concerns is a

Boron Epoxy patch. The current fasteners should be replaced with flush countersunk fasteners to remove some of the existing corrosion and provide a flat surface to bond a multiple layer Boron Epoxy patch. Such a patch will reduce the stresses at the crack tip and carry the load across the crack. Also, the patch would inhibit further crack growth, as well as crack growth from existing corrosion pits. Furthermore, since no new holes are required, new potential crack initiation sites would not be created. It appears that seven layers of Boron are needed in multiple directions to carry the hoop tension and longitudinal stresses from pressurization. An extension of the FEA work to investigate the Boron Epoxy repair is recommended.

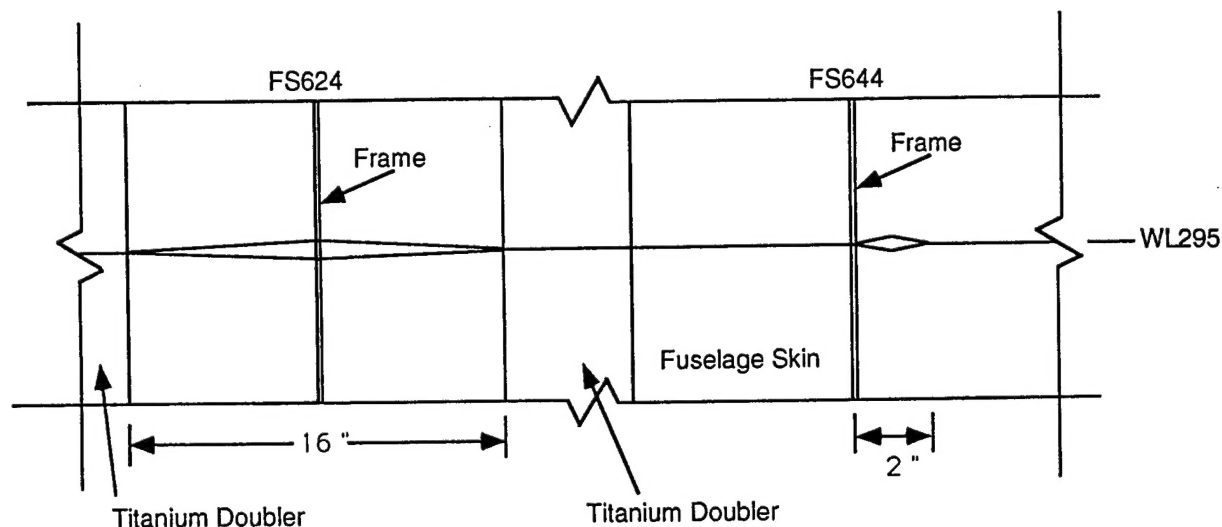
Figure 4: Cracks at WL 295; second crack pattern

Figure 4 shows the cracks along WL295 that were modeled to assess the effects of typical cracks on frames. Specifically, three cracks were modeled: one 16" crack along WL295 centered at FS624 was modeled to determine its effect on the frame at FS624; a 2" crack was modeled from FS644 to FS646 to obtain its effects on the frame at FS644; and one 0.15" crack was modeled at the fastener hole to determine the stresses in the fuselage skin ahead of the crack when a crack initiates and propagates from the fastener hole at an angle making 45 degrees with WL295.

Internal pressure: For the internal pressure load only, the maximum principal stress along WL295 rose from 19,110 psi to 19,700 psi; the stresses at the aft end of the hole along WL295 dropped from 19,080 psi to 16,130 psi. Table 3 shows the forces in the frames under various conditions. Note that a 16" crack increases the bending moment in the FS624 frame at WL295 from 7,503 in-lb to 22,777 in-lb, or 204%. The axial force increases from 5,350 lb to 10,599 lb, or 98%. The 2" crack near the frame at FS644 increases the bending moment by 25% and the axial force by 5%.

Internal pressure with cargo load: The maximum principal stress at the fore edge of the fastener hole, for this load case, rose from 20,380 psi to 20,540 psi; the principal stress at the aft edge dropped from 19,860 psi to 19,180, however. Table 3 shows the forces in the frames when the cargo load is present. A 16" crack caused the bending moment in the FS624 frame at WL295 to increase from 4,893 in-lb to

19,396 in-lb, or 296%. The axial force increased from 5,618 lb to 10,688 lb, or 90%. The forces in the FS644 frame did not change significantly, however.
